TWR - 17272, Vol. VI

FLIGHT SET 360L001 (STS-26) IGNITER,
POST FLIGHT, FINAL REPORT

5 APRIL 1990

FLIGHT SET 360L001 (STS-26)
IGNITER FINAL REPORT VOLUME VI

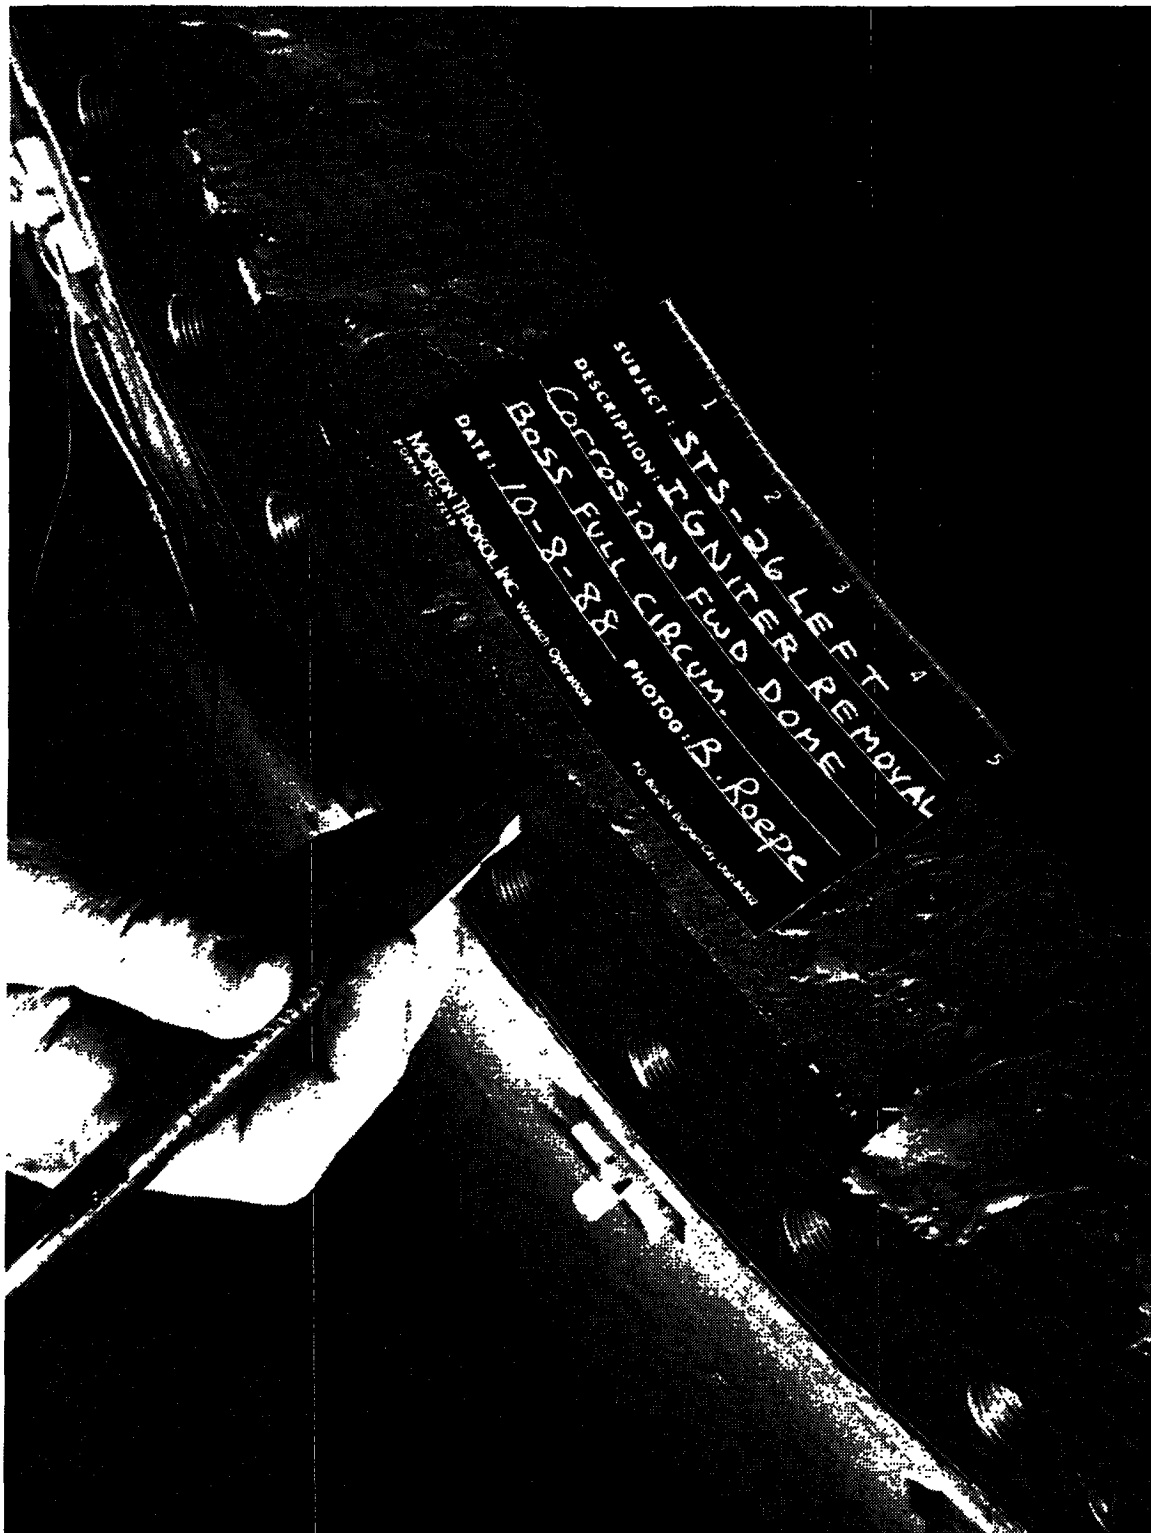
No evidence of hot gas leakage past the primary seal or damage on the joint or gasket seals was found. There was corrosion around the full circumference on the inside diameter of the forward dome boss and over the edge to the inside. Most of the corrosion was very light with a few heavier areas. None of the corrosion seen will affect the components ability to be refurbished. (Figure 5)

Figure 5. Igniter Forward Dome Boss Corrosion Left Motor

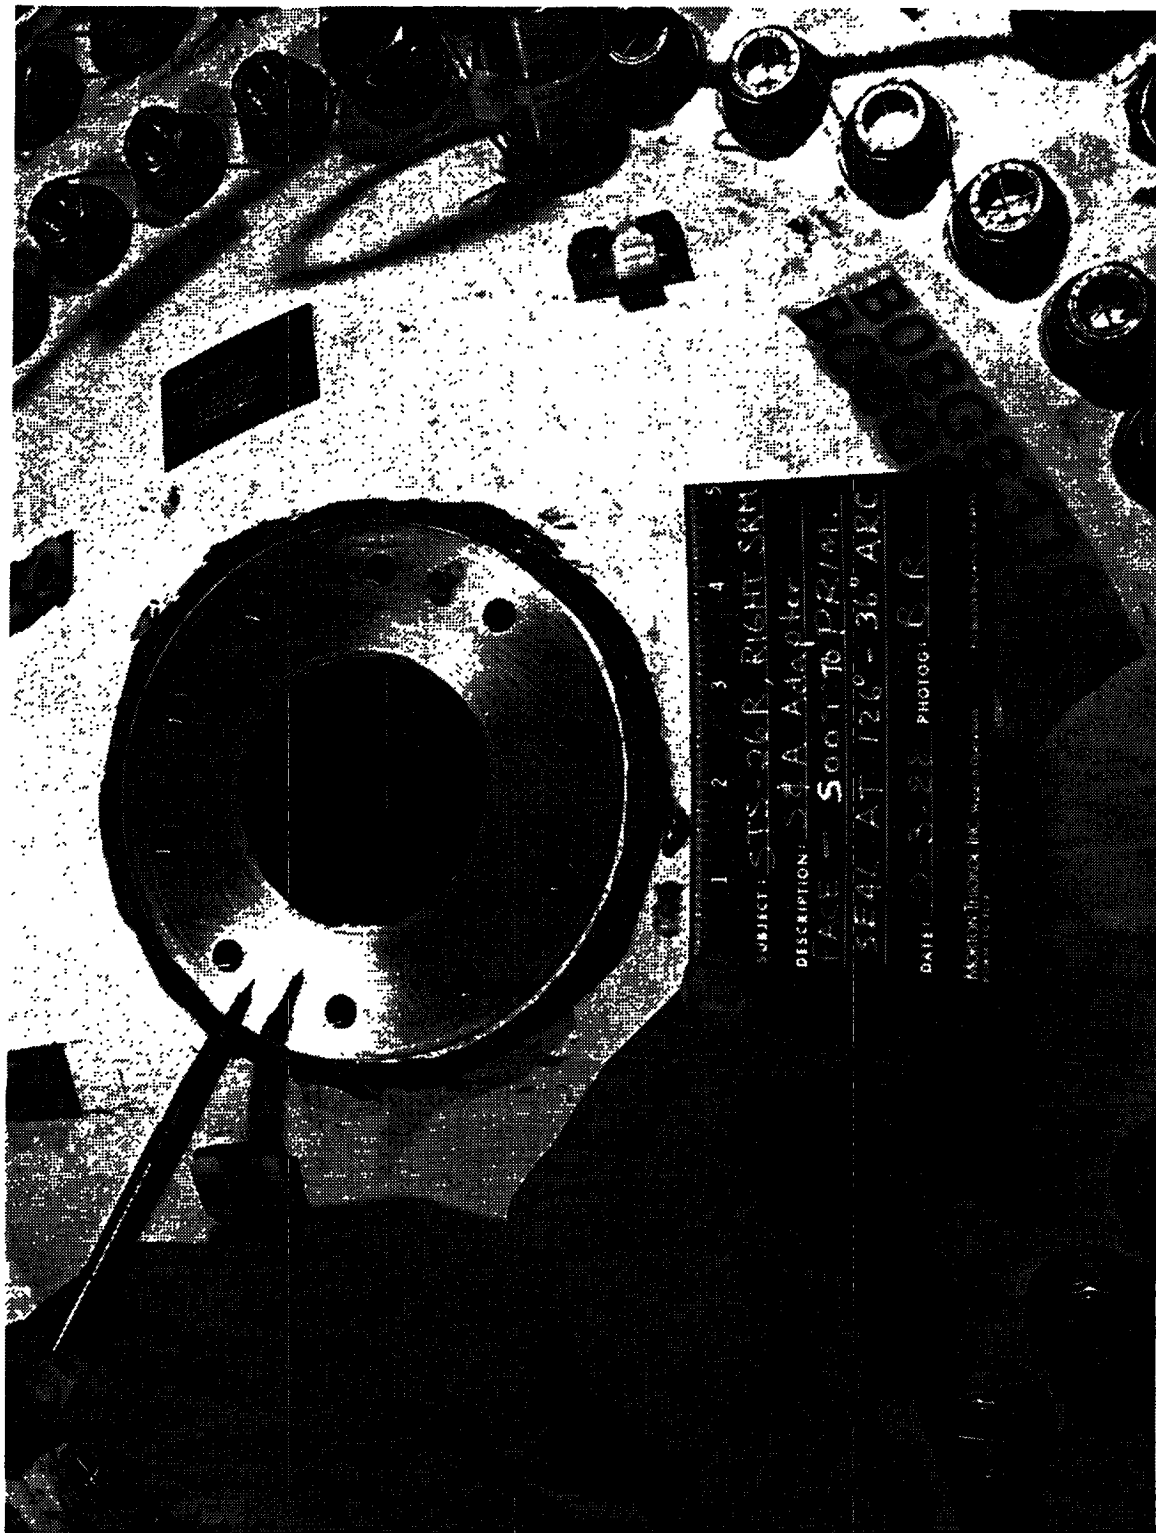
No evidence of hot gas past the primary seal on the Safe and Arm gasket was found. Soot was found on the primary seal on the aft side of the gasket from 108 to 144 degrees (36 degree arc). Soot was barely detectable on the gasket and was more evident on the igniter adapter surface. (Figure 7)

Figure 7. Safe and Arming Adapter Soot Right Motor

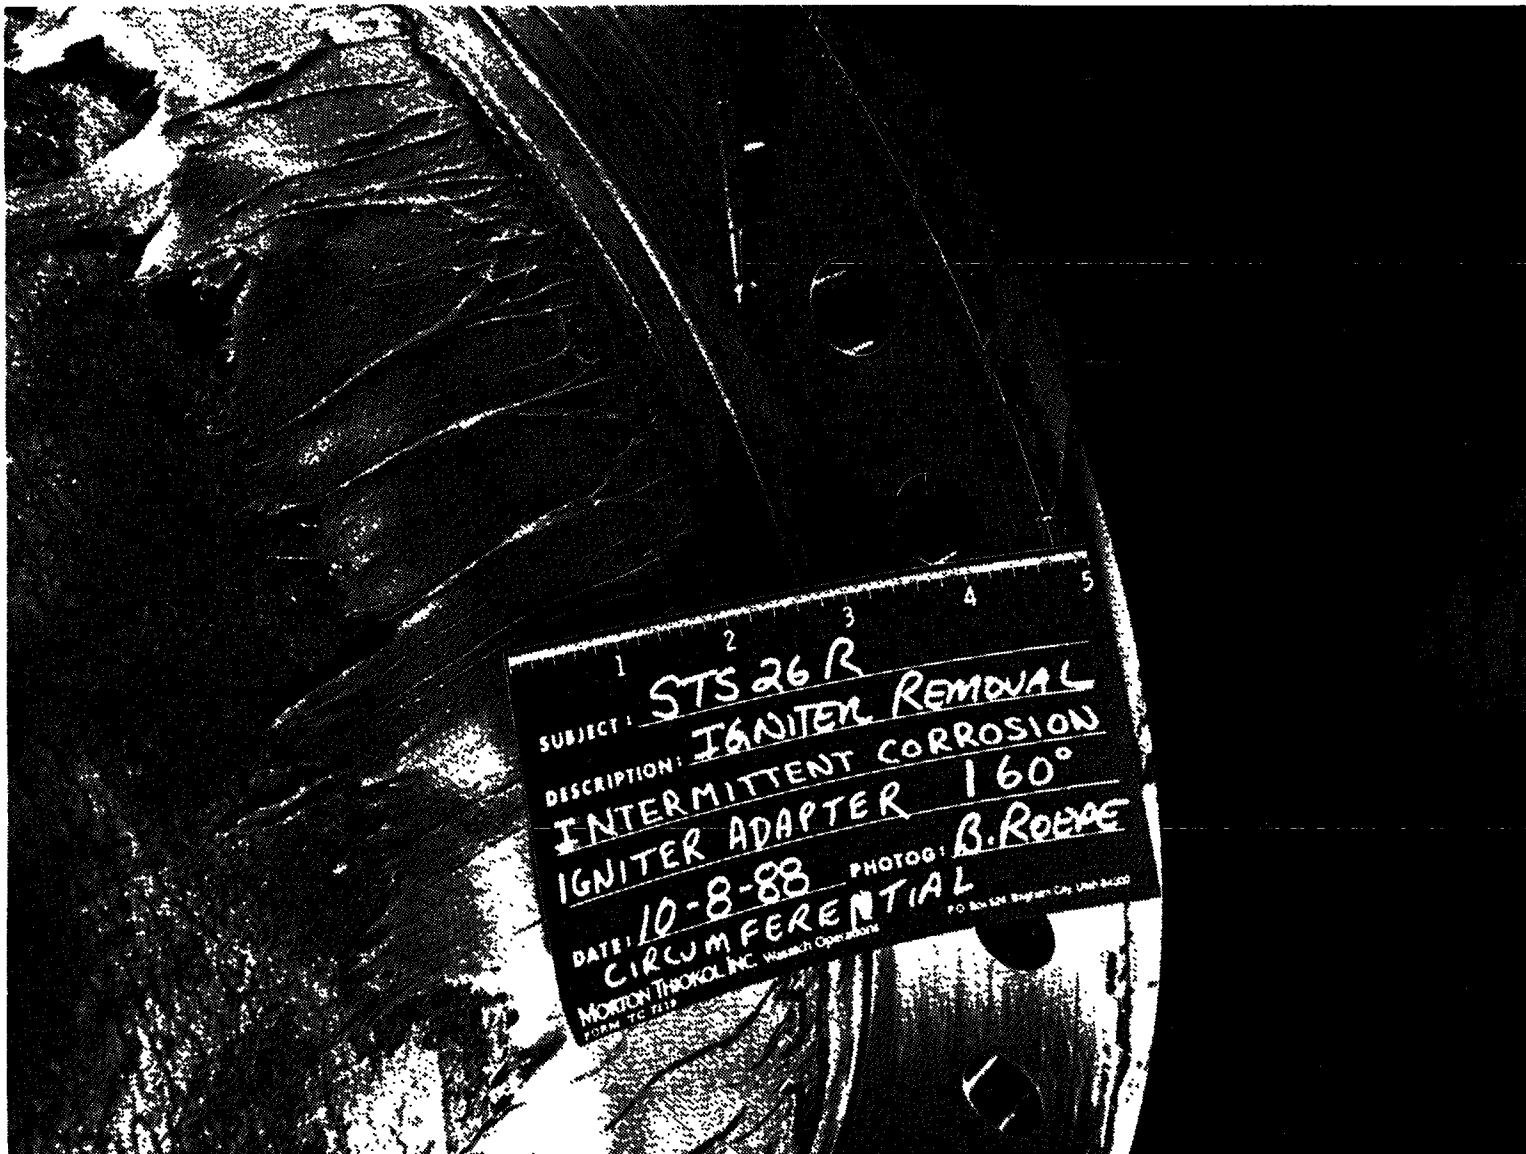
Corrosion was found on the inside edge of the forward dome boss and outside edge. This corrosion has been seen in the past. The corrosion occurs when the gases from the motor fill the volume past the putty and when sea water enters this cavity. The corrosion seen at this time will not affect the components ability for refurbishment. (Figure 11 and 12)

Figure 12. Igniter Adapter Corrosion Right Motor
